# MARITIME HERITAGE MINNESOTA

Ann Merriman  
Christopher Olson

## Suburban Lakes Nautical Archaeology 2 Project Report: Medicine Lake

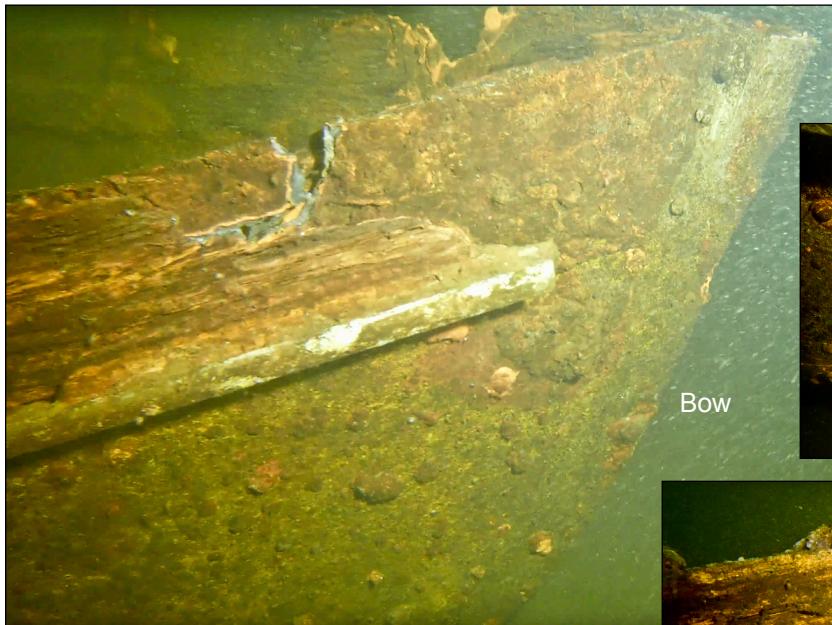
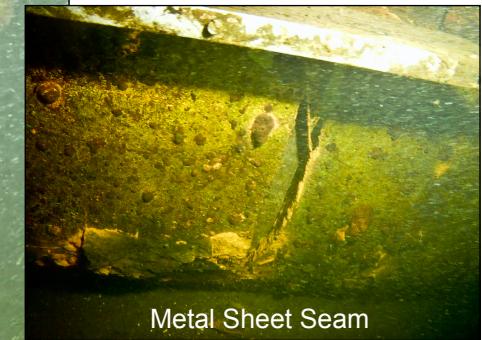
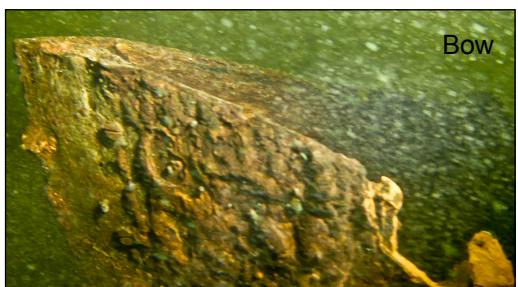
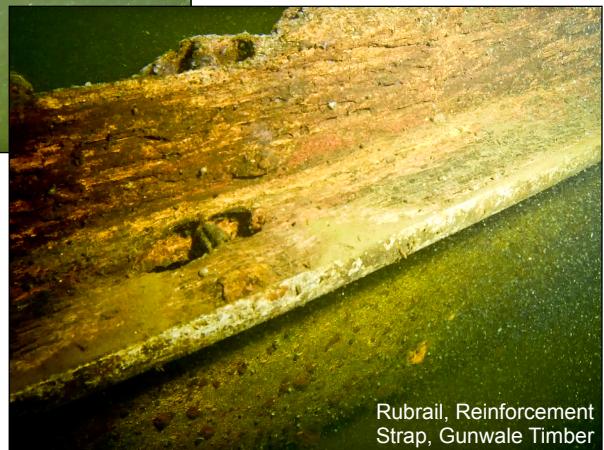
The Steel Launch Wreck's hull is fabricated from sheets riveted together and from what could be ascertained, each side has 3 sheets at a minimum, and the stern is an additional piece. The stempost is composed of wood and sheathed in steel; MHM supposes the keel is also constructed from steel-sheathed wood. Two considerable - although fragmentary - wooden gunwale timbers/stringers are attached to the outer and inner hull and a caprail survives in places. A substantial rubrail protrudes from the outer hull - also fragmentary in places - and it has a thin reinforcement strap attached to it. Slot-headed screws are visible at the bow and along the gunwale timber. Green and white paint survives in places on the rubrail, reinforcement strap, and gunwale timber, with some red paint also seen on the timber. The outer hull appears to be another shade of green, with rust spots seen all over the wreck. Anomaly 6 is strengthened inside throughout with wooden construction attributes including a keelson, sister keelson, floors, frames, futtocks, and an athwartships timber stern timber that likely supported a gas tank. The keelson is seen at the bow, amidships, and near the stern; it is covered in silt forward and it has a break in it toward the stern. The sister keelson is located amidships; it has a slot cut out of it to accommodate the shaft log that houses the propeller shaft before it disappears through the bottom of the hull. One small piece of Anomaly 6's ceiling planking survives on the starboard side forward, attached to a frame with a large drift pin. On the port side forward, 2 metal straps that end in flat hooks near the turn of the bilge can be found; they likely secured boat piping or electrical cords. At the turn of the bilge on the port side amidships, MHM contends a round hole cut through the hull was used to accommodate a water discharge pipe. A similar hole is located just under the rubrail on the starboard side forward.

Images of the Steel Launch Wreck (MHM).

Bow

Metal Sheet Seam

Rubrail, Reinforcement Strap, Gunwale Timber

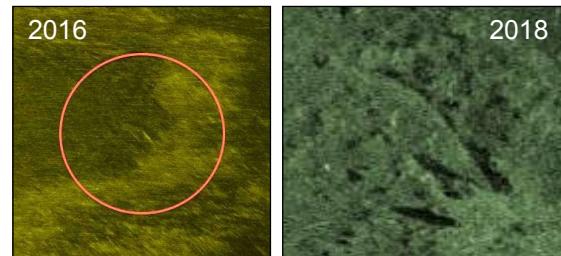
In 2016, MHM recorded sonar footage of Anomaly 36 that was distinct but among vegetation and therefore unidentifiable. During the MSLNA-2 Project, Anomaly 36's acoustical signature is larger and has increased detail, suggesting it may be an approximately 20.00-foot long wreck. However, the anomaly could also simply be a large tree or tree branch. MHM will investigate Anomaly 36 using SCUBA in the near future.

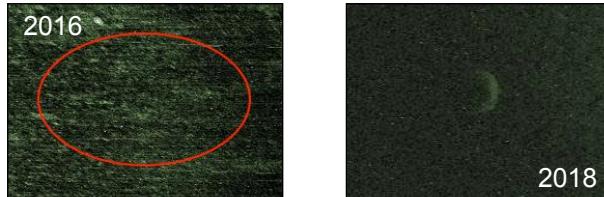
In 2016, MHM recorded sonar footage of Anomaly 70 that was indistinct but suggested a pointed object in vegetation. In 2018, the vegetation had shifted and an object is discernible; it may be a wreck. Anomaly 70 is approximately 12.00 feet long and SCUBA reconnaissance is necessary to identify it in the near future.

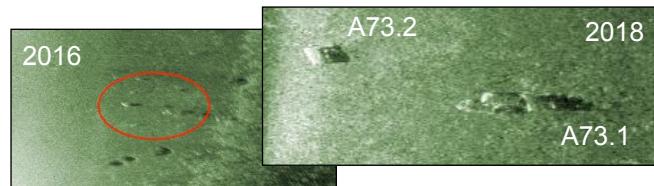
In 2016, MHM recorded sonar footage of Anomalies 73.1 and 73.2 that went unnoticed due to a lack of detail. The MSLNA-2 Project sonar recording of these anomalies has increased clarity and detail. MHM contends the objects may be 2 parts of a car; they resemble the body of a car and its engine that is 15 feet away. The Anomaly 73.1 is approximately 8.00 feet long and 73.2 is approximately 4.00 feet long. These anomalies will require SCUBA reconnaissance to identify them in the near future.
